# Manhole Inspection Summary

Manhole # S43A\_\_027MH

Insp Date: **3/1/08 11:22 AM**

**Location** Address: **Broadway**

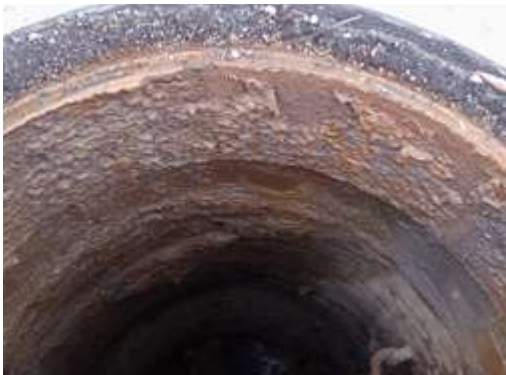
Defect 2

**Frame** Offset: **0** (in.) Condition: ☐ Sound ☐ Cracked ☒ **Leaks**

Frame Leaks

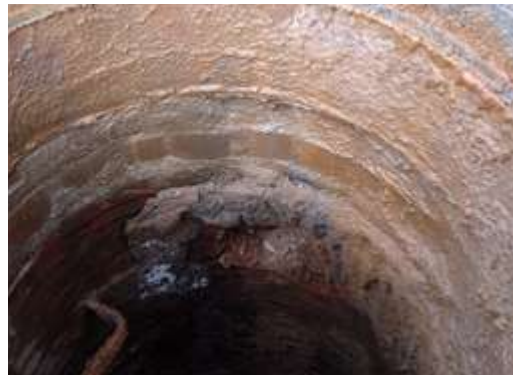
Defect 1

Condition: ☐ Sound ☐ Cracked ☐ Root Intrusion ☐ Loose Brick ☒ **Deteriorated**

Infiltration: ☐ None ☒ **Joint** ☐ Cracks ☐ Mortar ☐ Roots ☐ Wall

Missing Brick

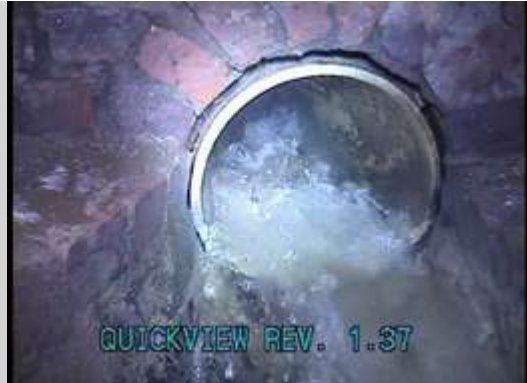
12 O'Clock Outflow

10 in. Circular Gravity Sewer  
Pipe Out @ 12 O'Clock

Pipe Height: **9.6** (in.) Rod and Bar (Angled)  
Pipe Material: **Clay** ☐ Pipe Lined  
Invert Depth: **10.70** (ft.) Flow Characteristics: **Fast**  
Deposits: ☒ None ☐ Mud ☐ Sludge ☐ Debris ☐ Grease  
Silt Depth: (in.) Deposits Extent:  
Infiltration: **None** Pipe Seal Cond: **Sound**

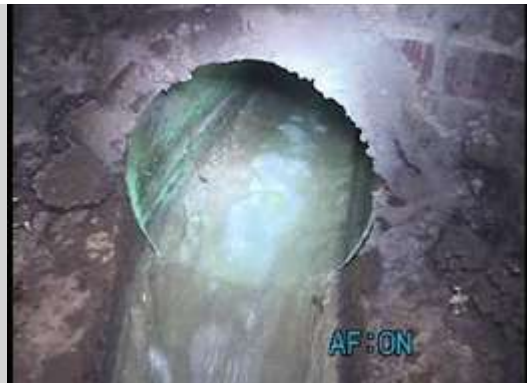
9 O'Clock Inflow

10 in. Circular Gravity Sewer  
Pipe In @ 9 O'Clock

Pipe Height: **9.6** (in.) Rod and Bar (Angled)  
Pipe Material: **Clay** ☐ Pipe Lined  
Invert Depth: **10.00** (ft.) Flow Characteristics: **Fast**  
Deposits: ☒ None ☐ Mud ☐ Sludge ☐ Debris ☐ Grease  
Silt Depth: (in.) Deposits Extent:  
Infiltration: **None** Pipe Seal Cond: **Sound**
